Faculty of Materials Engineering, Silesian University of Technology, Poland

Faculty of Engineering and Architecture, Ghent University, Belgium

Dissertation

**Assessment of fracture development in thick-walled elements of power boilers after
long-time operation**

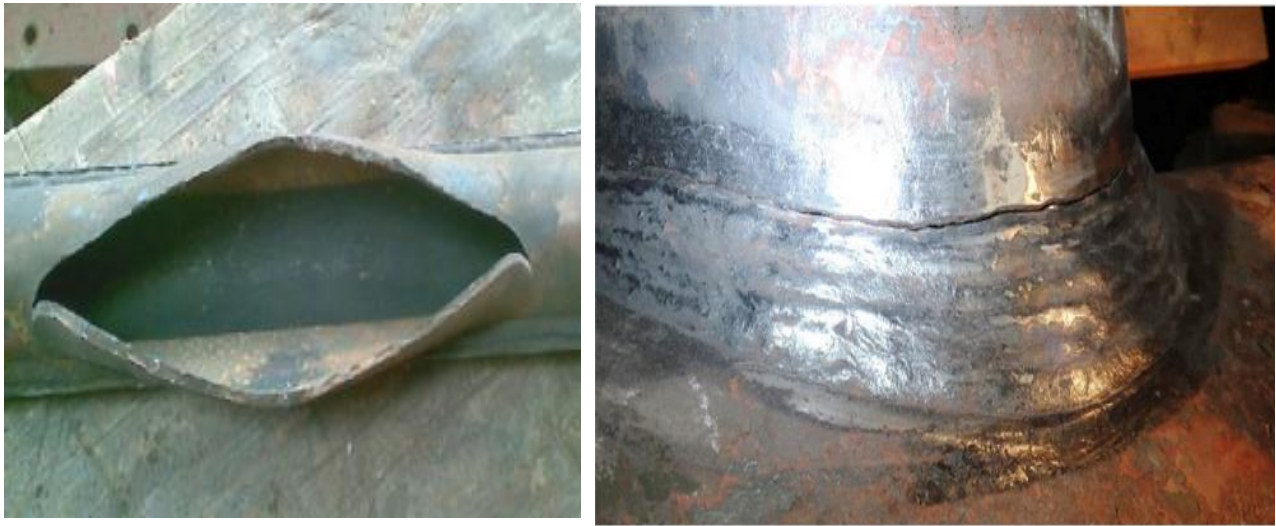
FIGURE 1: Ruptured boiler tube (a) [5], damage to the welding that connected the collector to the communication tubes (b) [12].

Several studies have recently reported on failure cases in electric power facilities. Leakage caused by crack development of boiler tubes, especially superheater and re-heater tubes, is a major reason for boiler shutdown and withdrawal from the network [8]. For example, flat plate ends are a popular choice for pressure boilers since they are less expensive than dished ends. They are best suited for vessels with thicker walls, boilers with lower internal diameters, and pipes with non-circular cross sections. These flat boiler heads are less expensive and easier to manufacture than standard ellipsoidal heads but have a disadvantage of high-stress concentration at the pipe shell-flat plate cover junction [9]. The presence of cracks or crack-like flaws in elements of power boilers can shorten their lifespan or cause catastrophic failure [10]. Regular boiler maintenance is required to prevent unexpected shutdowns [11].

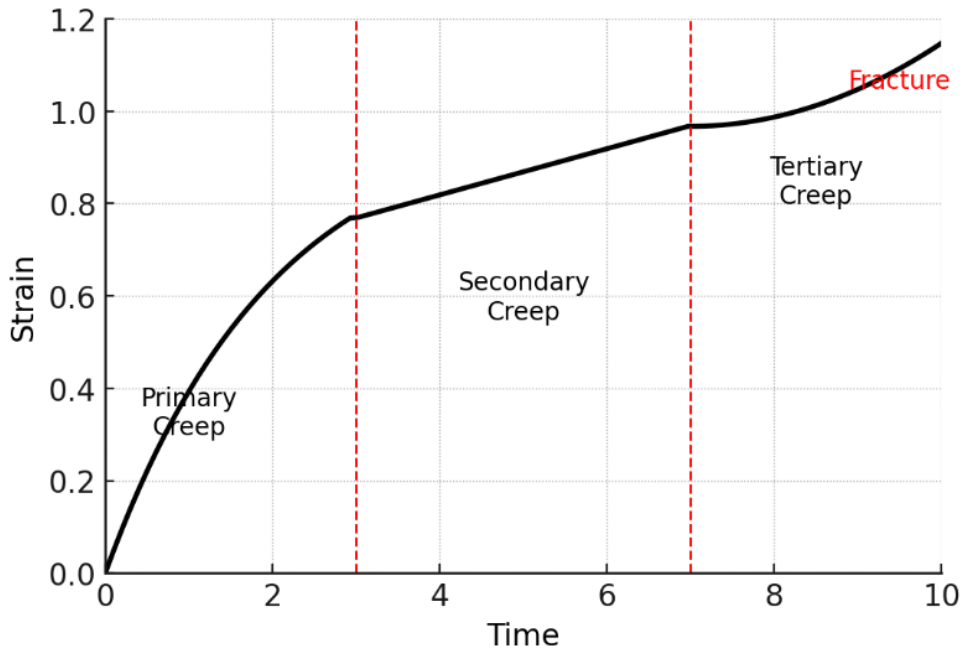
FIGURE 2: Stages of creep deformation [22].

[21] . Figure 2 depicts three stages of creep deformations. Creep increases significantly above 0.4 times the material's melting point. Even under continual stress, materials may gradually and constantly distort and ultimately fail because of thermal activation. Depending on the component, either deformation or fracture may limit the ultimate failure.

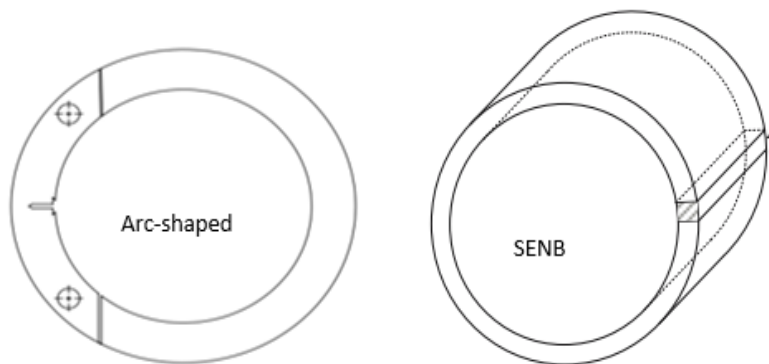
difference in crack tip constraints, according to ref. [22] since different specimen geometries have various crack tip constraints. During sampling for the SENB specimen, the load is axial, while for the arc-shaped specimen, the loads are radial, as depicted in Figure 35. The arc-shaped specimen is designated C-R while the SENB specimen is designated L-R as stipulated in the ASTM standard for fracture testing. This could be another reason for the difference in fracture toughness in the orientation of the specimens.

FIGURE 35: A schematic diagram showing the sampling position of the arc tension and SENB specimens.

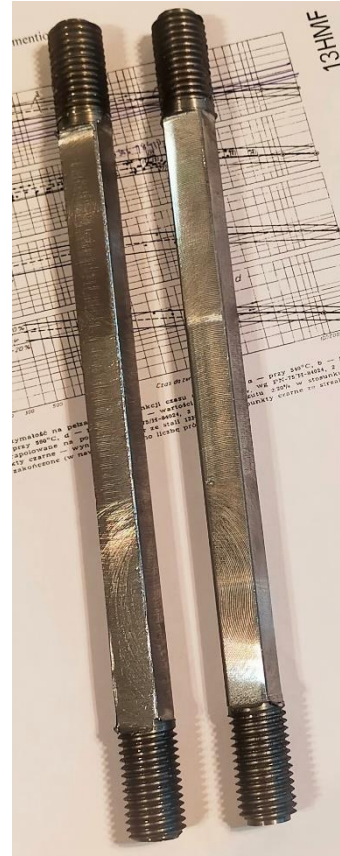
The specimens were machined to get the standard specimen size and create threads for gripping during creeping. The rod-like creep ageing specimens were machined along the rolling direction (RD) of the rods. These were specimens of 12 mm square cross-section and a gauge length of 140-180 mm and a thread of 16M as shown in the Figure 53.

FIGURE 53: The creep specimen

To imitate the elevated temperature working conditions of the material accelerated ageing was performed to degrade the structure of the materials using Kappa 05DS Zwick machine fitted with a furnace. 12 mm square-shaped specimen with a length of 170 mm where machined for all creep tensile testing. Creep tests were conducted atmospheric conditions at constant temperature of 540°C and as this is the operating temperature of boilers made with the studied steel grade. The temperature during thermal ageing was maintained at ± 2 °C. Creep elongations were continuously measured, using a linear variable differential transducer, recorded digitally and computer processed.

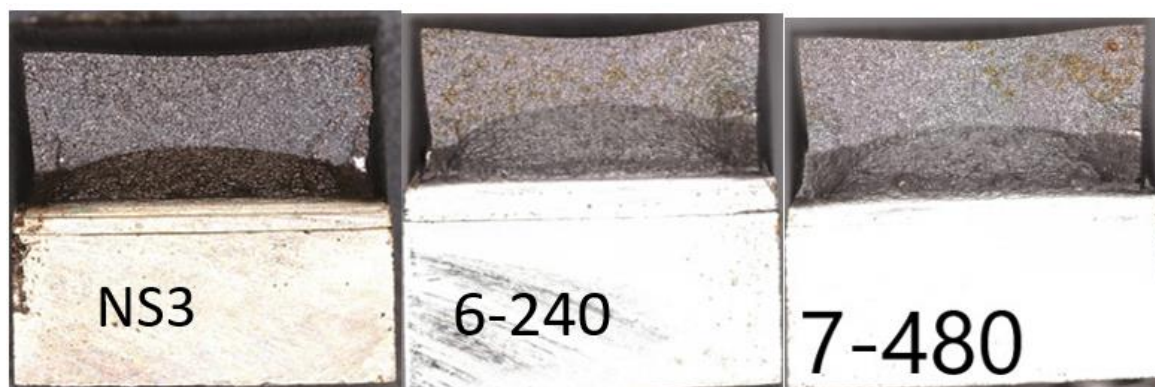
FIGURE 70: Fracture surface showing the crack front of new and aged specimen.

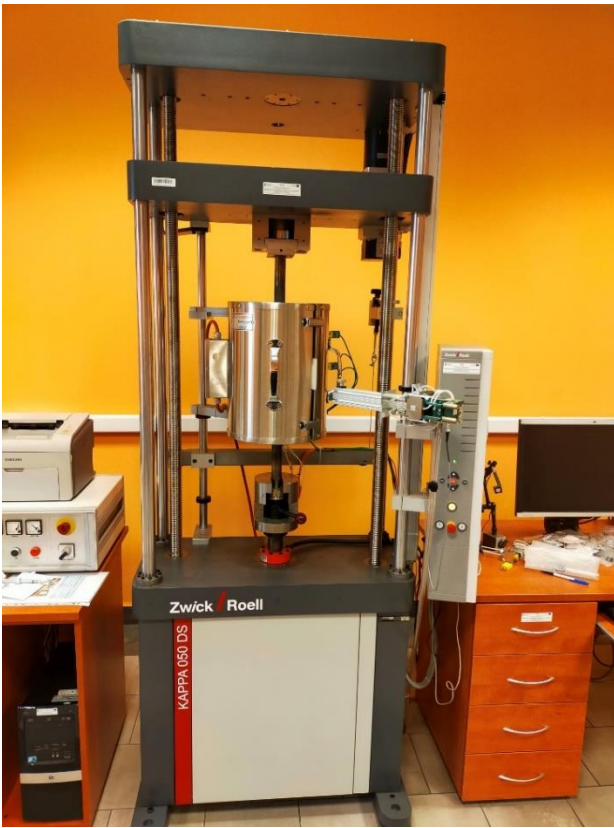
FIGURE 71: The 50 kN capacity kappa 050 ds Zwick/Roell creep testing machine fitted with controlled furnaces.

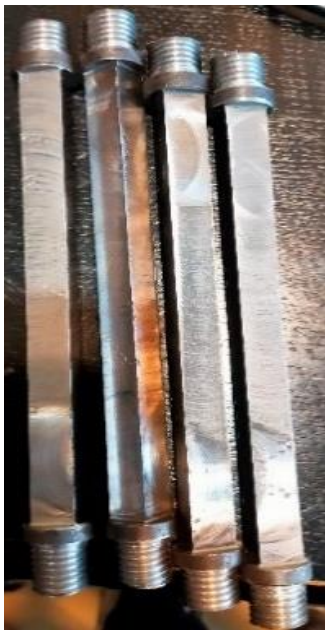
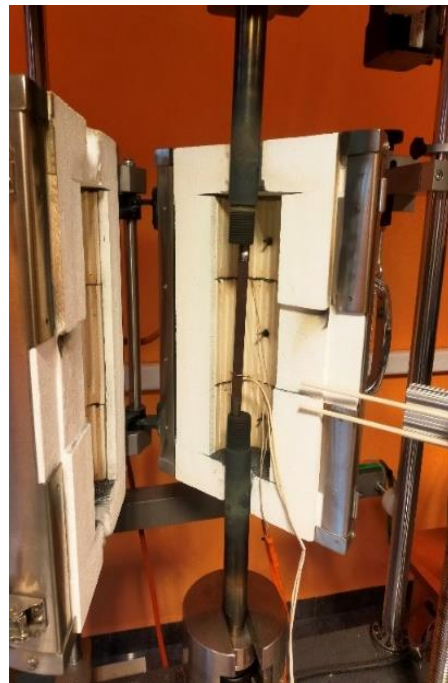
Specimens for creep degradation were machined into Standard Single Edge Notch Tensile Specimens (SENT) without a notch with a total length of 180 mm, and a gauge length of 100 mm between two gripping ends, the specimen featured a square cross-section of 12 mm as shown in figure 72 (b). The specimen's two ends were threaded to accommodate M16-threaded gripping jaws. The furnace, configured with three distinct heating zones, maintained a uniform temperature throughout as shown in Figure 72 (c). Temperature monitoring was achieved using five thermocouples: three were strategically placed within the furnace at the upper, middle, and lower regions, while two additional surface thermocouples monitored the specimen directly.

FIGURE 72: Creep test setup and instrumentations on the test specimen

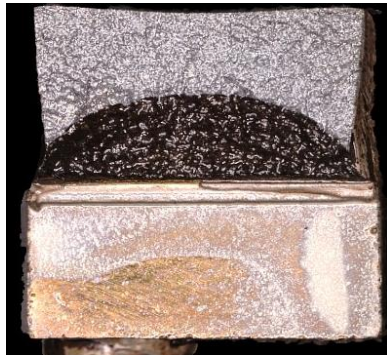
Creep degraded straight notch (C1)

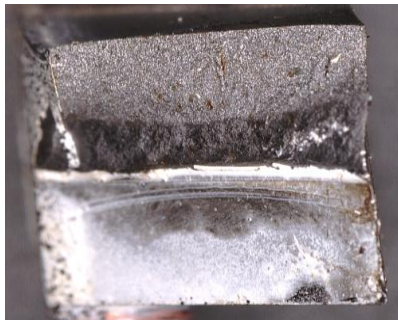
As received straight notch (N6-45)

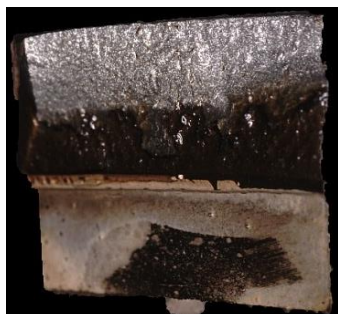
Creep aged 45-degree notch (4C)
